Stiffness, Ultimate Strength Capacity and Cyclic Loading Deterioration Characteristics of Two Different Wood-Structure Dwellings Following The Current Japanese Practice

Two Grade-3 index buildings were designed and constructed according to the current Japanese seismic design guidelines. One was a Post-and-Beam Structure (A-building), and another a Shear-Wall structure (B-building). The sills, column bases and wall bases were anchored to reinforced concrete foundations by steel anchor bolts, thereby fulfilling the guideline requirements. The foundations were firmly fixed, and shaking table motions were fully applied to the foundations. JMA-Kobe motion and JR-Takatori motion recorded in the 1995 Kobe earthquake were used for the ultimate state tests. The two test buildings had stiffness more than two times higher than the design evaluations. The ultimate strength capacities were more than four times that of the allowable stress design capacity.

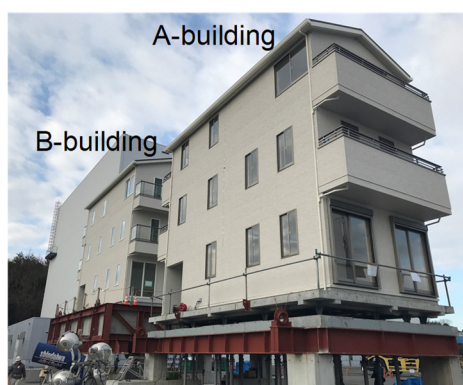
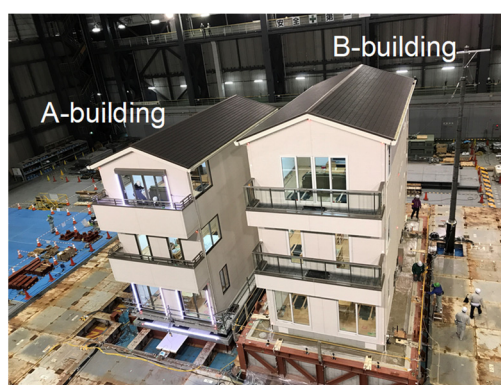
Fig. 1 Construction and setup of two wood test buildings (January, 2019)

(1) Construction site (outside west yard)

(2) Completion of setups in E-Defense

Comprehensive seismic performance assessment of wood dwellings located in densely populated urban areas was selected as a target of the current E-Defense tests regarding the Tokyo Metropolitan Resilience Project (2017-2022). “The 2019 full-scale shake table test program of wood dwellings” is summarized with the entire test results.^[1] This paper focuses on the evaluations of stiffness, ultimate strength capacity and cyclic loading deterioration characteristics of two different wood buildings shown in Fig. 1.

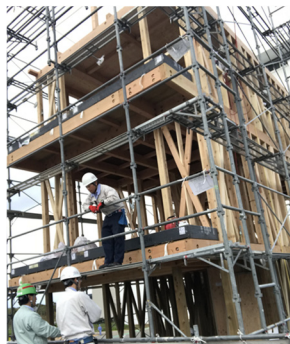
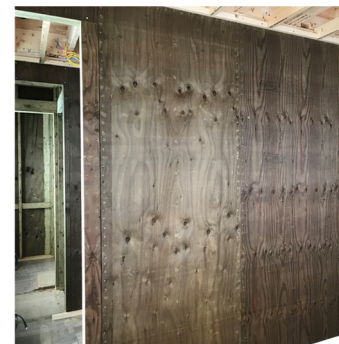
Fig. 3 Construction process of two test buildings (Photos: November-December, 2018)

(1) Post-and-Beam Structure / A-building

(2) Shear-Wall Structure / B-building

Figure 2 shows the plans of the first, second and third floors adopted for both A-building and B-building. The two test buildings had identical configurations and plans. Regarding the Post-and-Beam Structure (A-building), braces were fixed by metal connection reinforcement. Structural plywood was fixed by nails. The exterior wall was finished by siding boards. Gypsum board was fixed by screws to the interior side. The exterior wall was finished by wall cloth. The Shear-Wall structure (B-building) adopted prefabricated wall panels composed of a vertical frame, lateral frame and plywood. The siding board, gypsum board and wall cloth were the same in both test buildings. Figure 3 shows the construction process of the test buildings.

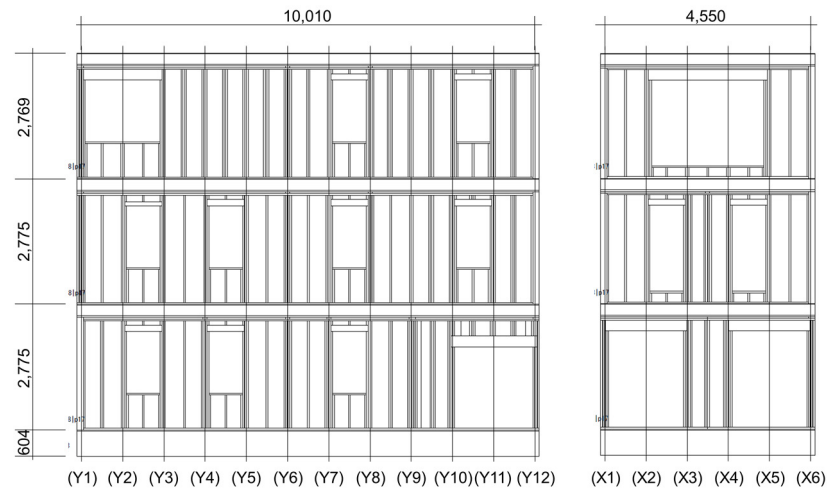
Fig. 4 Framing elevation

Table 1 shows the seismic force used in the designs of A-building and B-building. Figure 4 shows the framing elevation. For both buildings, the design of the Grade-3 index building was adopted so that the strength

(1) A-building (Post-and-Beam Structure)

(2) B-building (Shear-Wall Structure)

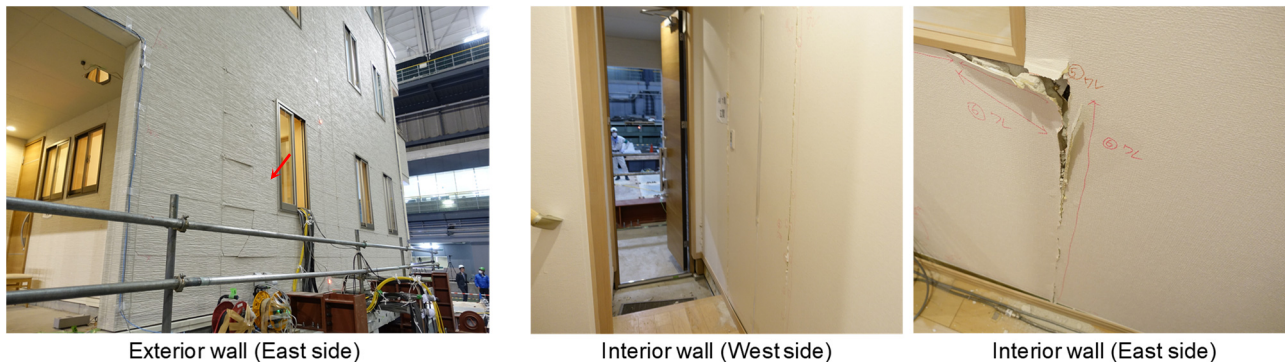
Fig. 7 Damage to the first story of A-building in the story drift of 0.03 rad (JMA-Kobe 100%)

The maximum inter-story drift angle was limited to less than 0.008 rad in JMA-Kobe 50%. JMA-Kobe 50% is equivalent to the Design-Based Earthquake. On the other hand, when subjected to JMA-Kobe 100%, the response deformation was concentrated on the first story, and the drift angle exceeded 0.03 rad in the X-direction. The maximum inter-story drift exceeded 0.04 rad in the following JR-Takatori 100%. Figure 7 shows the typical damage to the first story after being subjected to JMA-Kobe 100%. In the X-direction, the siding boards fractured in the exterior walls. Significant cracks started at the corners of windows in the interior gypsum boards. In the JR-Takatori 100%, the siding boards spalled from the exterior walls, as shown in Fig.

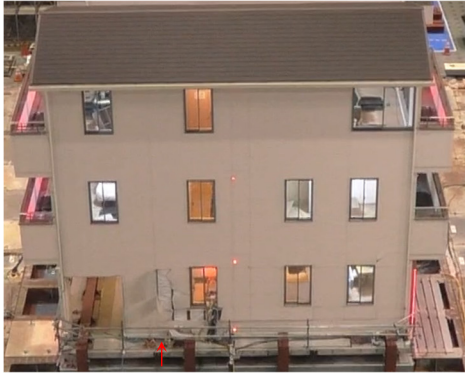
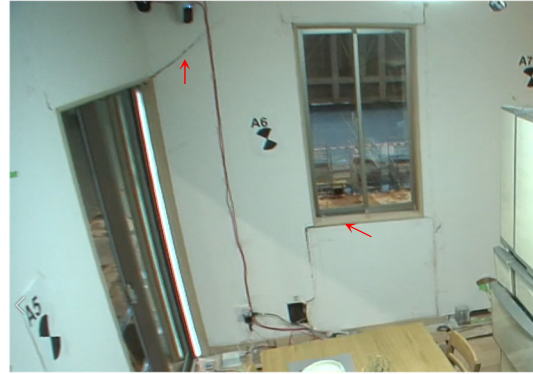
Fig. 8 Video capture of interior and exterior walls when subjected to JR-Takatori 100% (A-building)

8 (1). Cracks progressed slightly in the interior walls under cyclic deformations, as shown in Fig. 8 (2). Note that the steel anchor bolts holding the column bases showed maximum strain slightly exceeding 0.2%, and column bases constraint vertical deformations due to tension forces. The first-story deformation comprised mostly of story shear deformation.

(1) Fractured and spalled siding boards came off in the cyclic drift angle of 0.04 rad

(2) Cracks slightly progressed in the interior walls under cyclic deformations

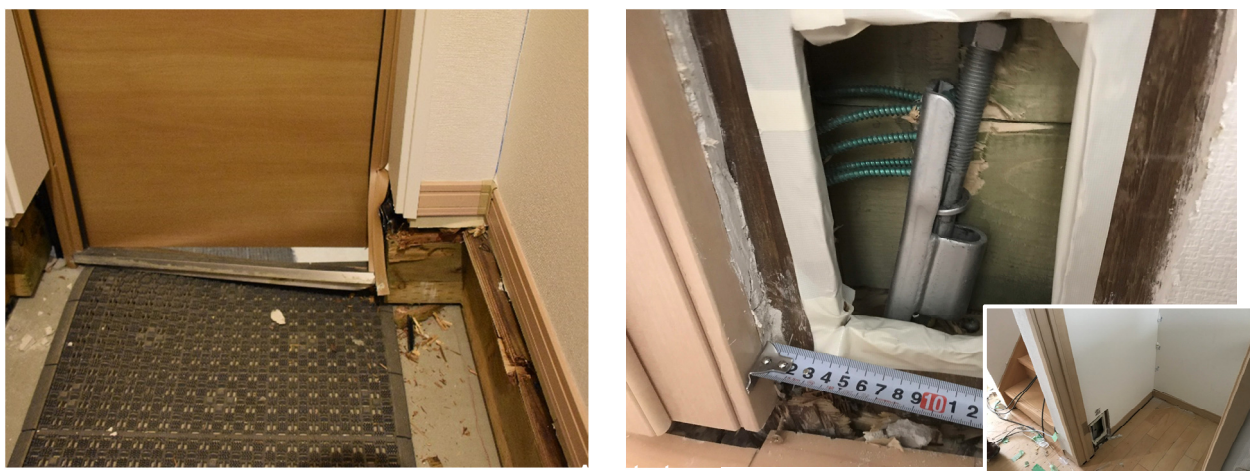
Fig. 11 Wall base fracture at the south exterior wall and screws pulled out at column base (B-building after subjected to JMA-Kobe 100%)

When subjected to JMA-Kobe 100%, the table input motion was fully applied to the foundation of B-building. Figure 11 shows the ultimate failure states of B-building. Severe fractures of the wall base occurred at the interface between shear wall panels and sills. Regarding the steel anchor bolts holding the column base, the screws were completely pulled out from the column base. The overviews captured at the moment of the wall base fractures (Fig. 12) indicated that the overturning moment due to significant inertia force in the Y-direction uplifted the south exterior frame. The recorded maximum value of uplifting was more than 400 mm.
