Test Results of Four-Story Reinforced Concrete and Post-Tensioned Concrete Buildings: The 2010 E-Defense Shaking Table Test

Two full-scale building structures were tested using a large shaking table facility, E-Defense. One was a four-story reinforced concrete building designed according to the present Japanese seismic design code, and the other was a four-story prestressed concrete building utilizing precast post-tensioned concrete members. Presented here are summaries of the global behaviors of both structures and key local damage and deformation observations. A comparison between the performances of the two structures is also presented.

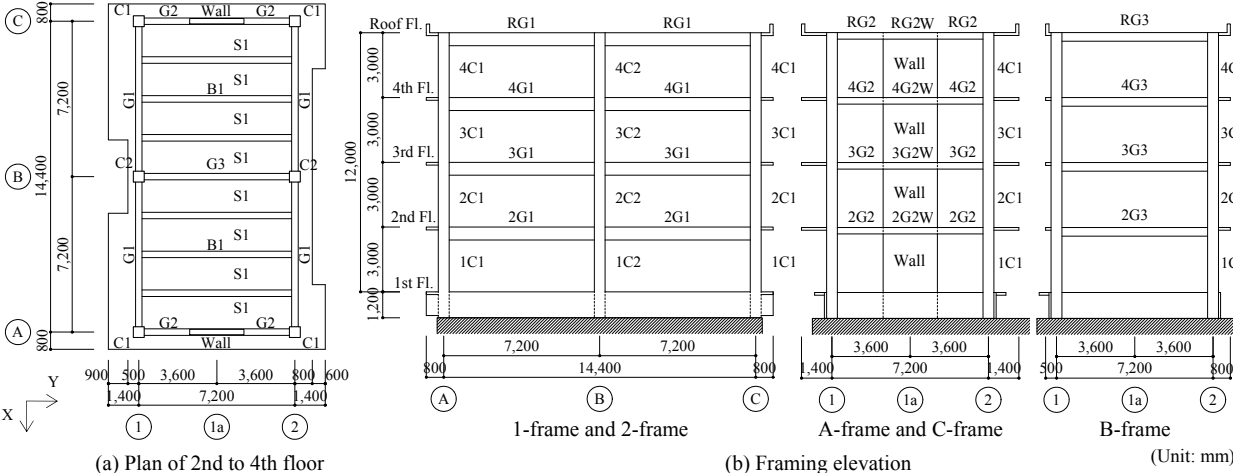
Figure 1. Configuration of test specimen (RC specimen)

frames in the shorter (Y) direction of one span of 7.2 m. Figure 1 shows the plan and framing elevation of RC specimen. In this series of tests, RC specimen and PT specimen were set on the E-Defense shaking table and shaken simultaneously. Figure 2 shows the test setup of RC and PT specimens. The foundations were fixed on the shaking table by a number of prestressing post-tensioned bars. Column sections of RC specimen were 500 mm x 500 mm, and column sections of PT specimen were 450 mm x 450 mm. In the moment frame of X direction, the beam depth in RC specimen was 600 mm, and the beam depth in PT specimen was 500 mm. The wall section of both specimens was 250 mm x 2500 mm. Walls were coupled to the corner columns by beams with a depth of 300 mm. The thickness of the top slab was 130 mm and the foundation beam had a depth of 1200 mm. Strong steel frames were set in the specimens for collapse prevention and measurement of story deformations. Also, equipment was incorporated for additional research to assess the functionalities of building. The weights of the specimens were estimated based on the structural members, the fixed steel frames, and the equipment. The total weight of RC specimen was estimated at 5877 kN. The weights of the floors of RC specimen, from the second floor to the roof floor were 867 kN (2nd Fl.), 872 kN (3rd Fl.), 867 kN (4th Fl.), and 934 kN (Roof Fl.). The total weight of PT specimen was estimated at 5592 kN. The weights of the floors of PT specimen were 804 kN (2nd Fl.), 806 kN (3rd Fl.), 813 kN (4th Fl.), and 996 kN (Roof Fl.).

RC specimen and PT specimen having almost the same configurations and overall dimensions were prepared. The height of each story is 3 m. The moment frame system was adopted in the longer (X) direction of two spans of 7.2 m, and a pair of multi-story walls were incorporated in the exterior

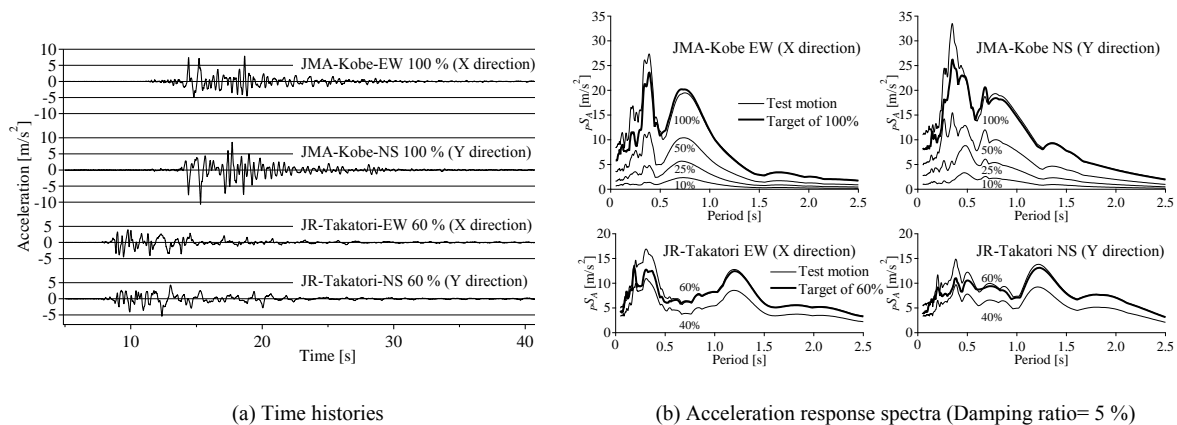
Figure 5. Input ground motion

JMA-Kobe and JR-Takatori recorded in the 1995 Hyogoken-Nanbu earthquake were adopted as the input ground motions. The NS-direction wave, EW-direction wave, and UD-direction wave were input to the Y direction, X direction and vertical direction of the specimen respectively. Time histories and acceleration response spectra for the input motions are presented in Figure 5. The intensity of input motions was gradually increased to observe the damage progress. The adopted factors for JMA-Kobe were 10 %, 25 %, 50 %, and 100 %. Following the JMA-Kobe motions, the JR-Takatori motion scaled to 40 % and 60 % was applied to impart large cyclic deformations. White-noise inputs were applied prior to each main test. The initial natural period of RC specimen was 0.43 sec in X direction and 0.31 sec in Y direction. The initial natural period of PT specimen was 0.45 sec in X direction and 0.29 sec in Y direction.

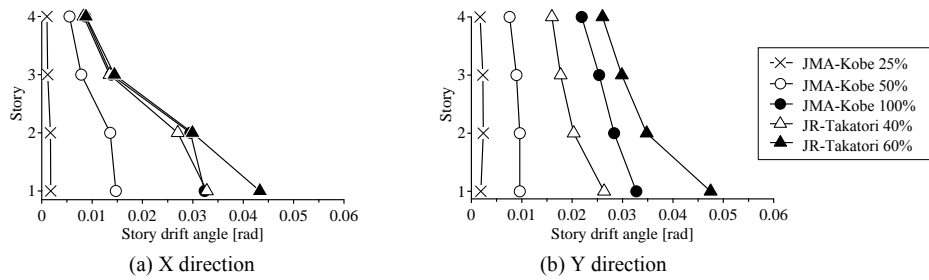
Figure 6. Maximum inter-story drift distribution of RC specimen

Figure 6 shows the distribution of maximum inter-story drifts over the height of RC specimen. Those were estimated at the center of floor. For the JMA-Kobe-25% test, the maximum inter-story drifts were smaller than 0.004 rad in X and Y directions. For the JMA-Kobe-50% test, the maximum inter-story drift in the first story was 0.015 rad in X direction and 0.010 rad in Y direction. For the JMA-Kobe-100% test, the maximum inter-story drift in the first story exceeded 0.03 rad in both X and Y directions. In X direction, the maximum inter-story drifts in the first and second stories were about twice that of the third story. In Y direction, the distribution was relatively uniform, although the

maximum inter-story drift tended to grow in the first story. For the JR-Takatori-60% test, the maximum inter-story drift in the first story exceeded 0.04 rad in X and Y directions.

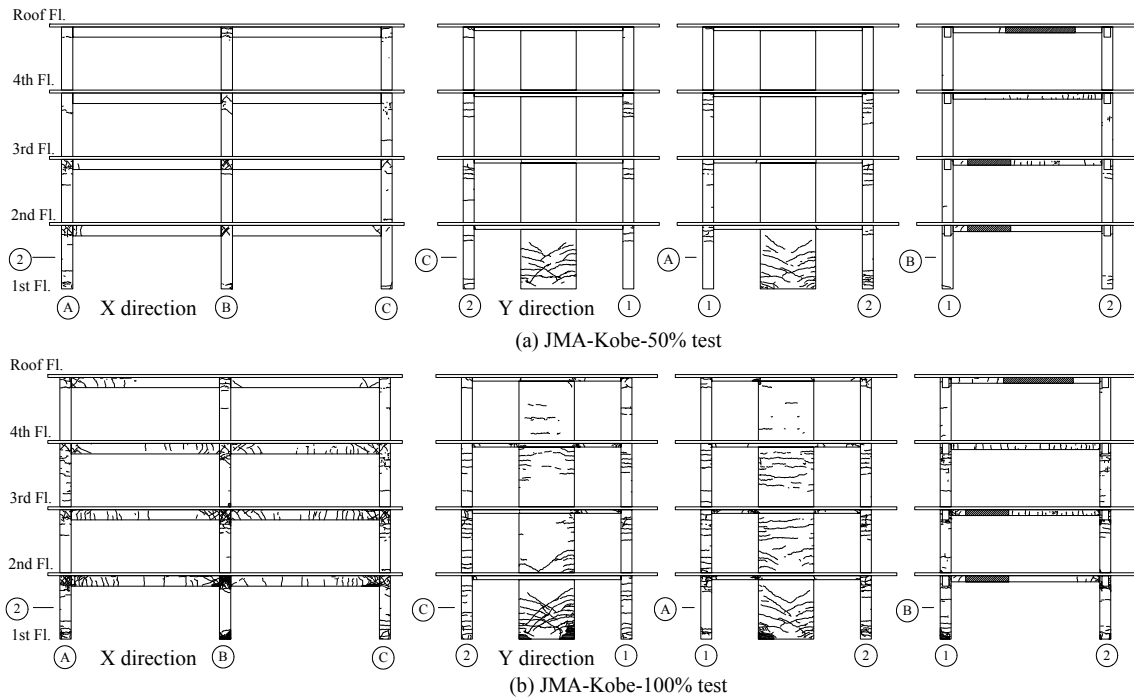
Figure 7. Overall damage states of RC specimen observed after JMA-Kobe-50% and JMA-Kobe-100% tests

Figure 7 shows overall damage states of RC specimen observed after the tests. The beam-column joints, beam ends, column and wall bases showed minor cracking after the JMA-Kobe-50% test. Although the maximum measured shear crack width was 0.5 mm after the JMA-Kobe-50% test, the maximum shear crack width in interior beam-column joints reached 2.5 mm after the JMA-Kobe-100% test. The maximum shear crack widths at beam ends and exterior beam-column joints were limited to 1.1 mm after the JMA-Kobe-100% test. The cover concrete of first story column bases partially spalled to a height of 250 mm in the JMA-Kobe-100% test. The corner of first story wall bases suffered compressive failure to a height of 300 mm and width of 600 mm in the JMA-Kobe-100% test. The longitudinal reinforcement buckled in that region. Wall sliding at the base was observed in the JMA-Kobe-100% and subsequent tests.

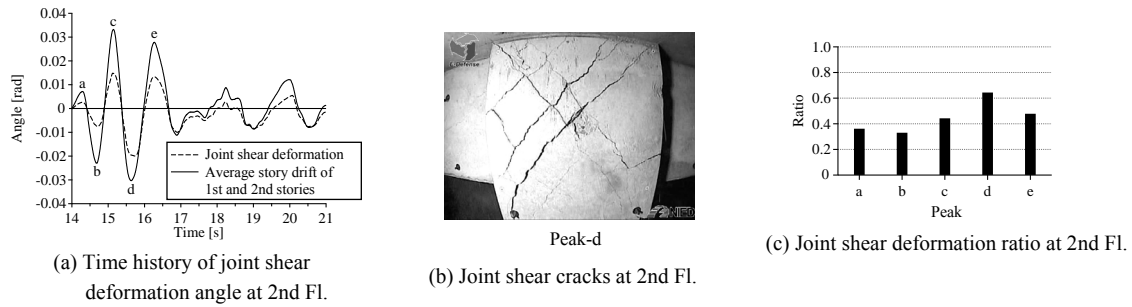
Figure 8. Local damage and deformation of RC interior beam-column joint in JMA-Kobe-100% test

Shear deformation of the beam-column joints was measured in X direction. In the JMA-Kobe-100% test, the interior joint suffered severe damage at 2nd Fl. Figure 8 (a) shows the time history of the shear deformation angle of the 2nd Fl. joint, comparing to the average inter-story drift angle of the upper and lower stories. Peaks of the inter-story drift were noted as a to e in the histories. The joint shear deformation significantly increased at Peak-c and Peak-d due to the cyclic large inter-story drifts of about 0.03 rad. As shown in Figure 8 (b), the significant shear cracks were observed at Peak-d. Figure 8 (c) shows the shear deformation ratio corresponding to Peak-a to Peak-e. The shear deformation ratio was defined as the joint shear deformation angle divided by the average inter-story

drift angle. The deformation ratio was about 0.3 at Peak-a and increased to 0.6 at Peak-d.

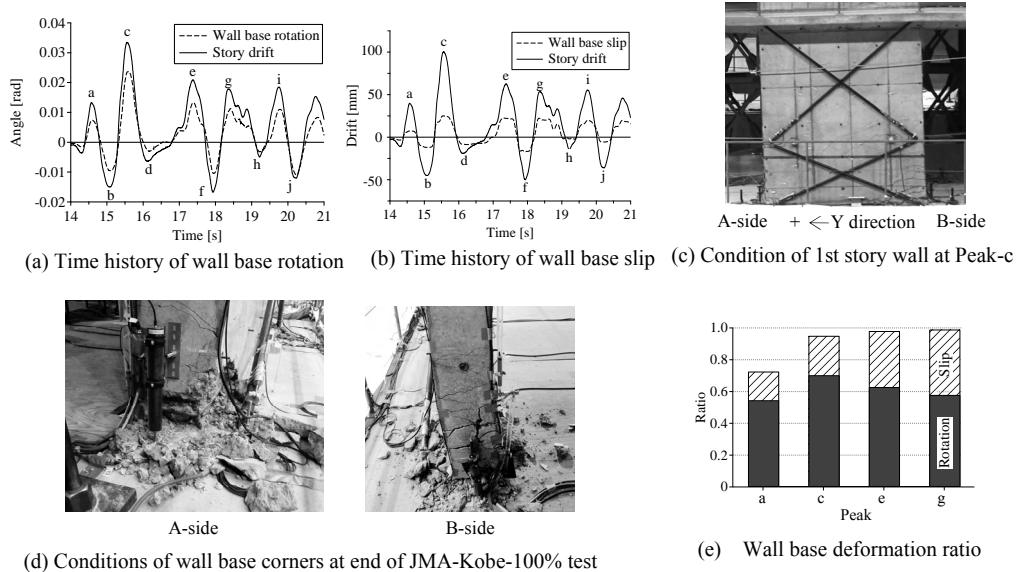
Figure 9. Local damage and deformation of RC wall base at C-axis for JMA-Kobe-100% test

Rotation and lateral slip deformations of the wall bases were measured in Y direction. Figures 9 (a) and (b) show the time histories of the wall base rotation and slip in the JMA-Kobe-100% test, comparing to the first story drift. Peaks of the inter-story drift were noted as a to g in the Figures. Figure 9 (c) shows the condition of the first story wall sustaining the large inter-story drift of 0.034 rad at Peak-c. A local compressive failure is seen at the base corner of A-side, and notable tension cracks due to the large inter-story drift are seen in the lower part of B-side. Figure 9 (d) shows the conditions of wall base corners at the end of JMA-Kobe-100% test. According to video observations, in the cycle when the inter-story drift approached Peak-d, the severe local buckling of bars occurred at the base of B-side due to the previous significant tension of bars at Peak-c. Figure 9 (e) shows the deformation ratios at the peak inter-story drift. The deformation ratios were defined as the ratio of wall base rotation and slip to the inter-story drift. At Peak-c, the inter-story drift was mostly derived from the rotation, with the deformation ratio of 0.7. Since the slip deformation becomes constant after the maximum deformation at Peak-c, the deformation ratio of the slip increased to 0.4 at Peak-g.

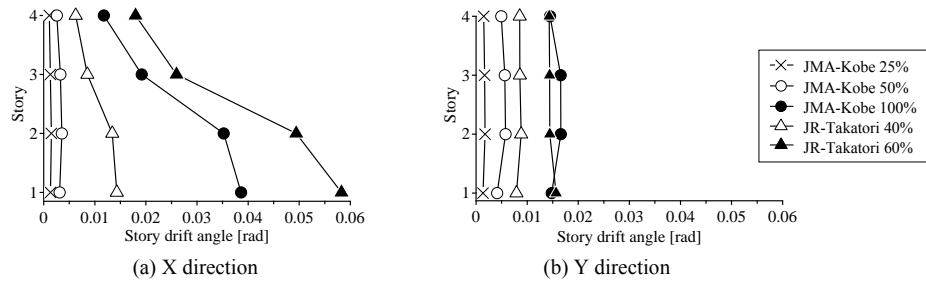
Figure 10. Maximum inter-story drift distribution of PT specimen

Figure 10 shows the distribution of maximum inter-story drifts over the height of PT specimen. Those were estimated at the center of floor. For the JMA-Kobe-25% test, the maximum inter-story drifts were smaller than 0.003 rad in X and Y directions. For the JMA-Kobe-50% test, the distributions were relatively uniform in X and Y directions, and the maximum inter-story drift in the second story was 0.004 rad in X direction and 0.006 rad in Y direction. For the JMA-Kobe-100% test, the maximum inter-story drift in the first story reached 0.039 rad in X direction, while the maximum inter-story drift

in the first story only reached 0.015 rad in Y direction. In X direction, the maximum inter-story drifts in the first and second stories were about twice that of the third story, while in Y direction the distribution remained relatively uniform. For the JR-Takatori-60% test, the maximum inter-story drift in the first story was 0.058 rad in X and 0.015 rad in Y direction.

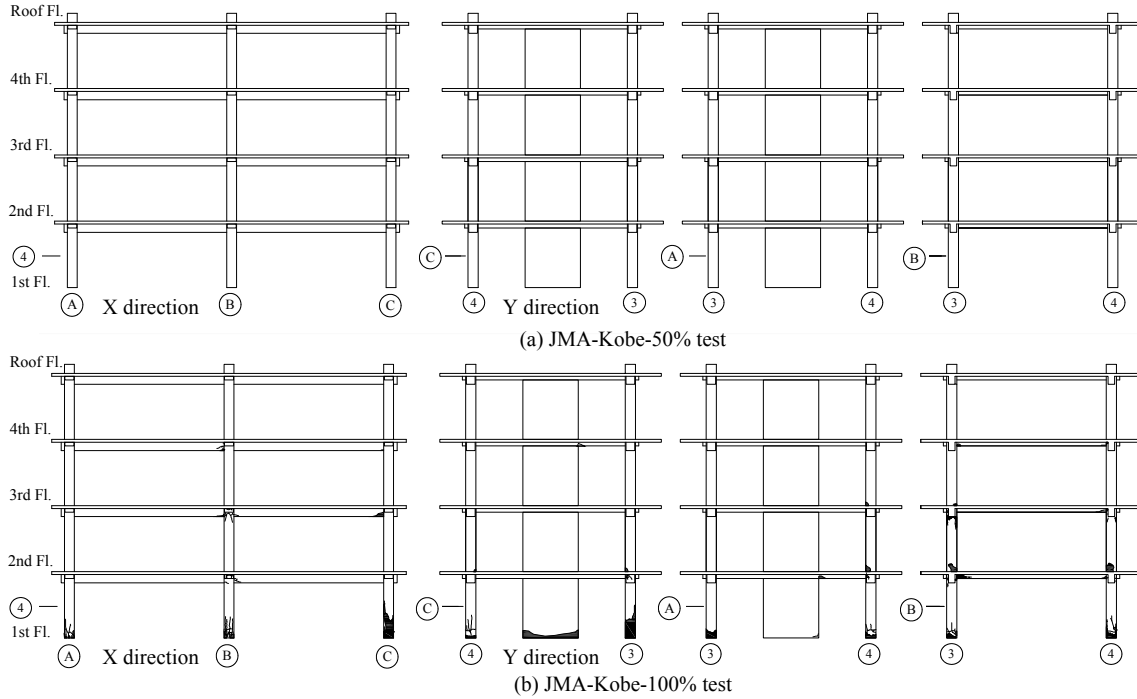
Figure 11. Overall damage states of PT specimen observed after JMA-Kobe-50% and JMA-Kobe-100% tests

Figure 11 shows overall damage states of PT specimen observed after the tests. After the JMA-Kobe-50% test, no obvious damage was observed. After the JMA-Kobe-100% test, compressive failure of concrete due to large story drift of X direction was observed in beam ends and column bases. In X direction, minor shear cracks were also observed in the interior and exterior beam-column joints. The cover concrete of the first story wall base partially spalled to a height of 250 mm in the JMA-Kobe-100% test at C-axis. Note that wall panels and grout bases made of steel fiber reinforced concrete and steel fiber reinforced mortar were used in the first and second stories of A-axis but not of C-axis. For the JMA-Kobe-100% test, an obvious torsional motion was observed in Y direction, indicating the different degrading behaviors of the two walls. As a result, the wall at C-axis sustained larger deformations than that at A-axis.

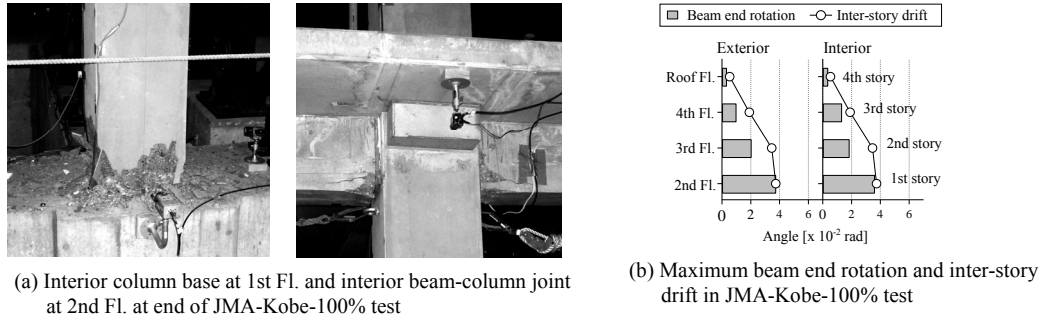
Figure 12. Local damage and deformation in PT moment frame for JMA-Kobe-100% test

Figure 12 (a) shows the local damage to the PT moment frame at the end of JMA-Kobe-100% test. Just above the foundation, the interior column exhibits compressive failure with the cover concrete spalling up to a height equal to the sectional depth of the column. At the 2nd Fl. beam-column joint, the bottom corners of the beams exhibit compressive failure due to negative bending (top in tension). Rotation of the beam ends were measured in X direction. Figure 12 (b) shows the maximum beam end rotation angles and the maximum inter-story drift angles. In the JMA-Kobe-100% test, the maximum

inter-story drifts exceeded 0.03 rad in the first and second stories. In the Figures, the beam end rotation angle at the 2nd Fl. is close to the first story drift angle, and the beam end rotation angle at the 3rd Fl. is half the second story drift angle. These measurements indicate that the top part of the columns in the second story yielded resulting in a partial mechanism of the first and second stories.

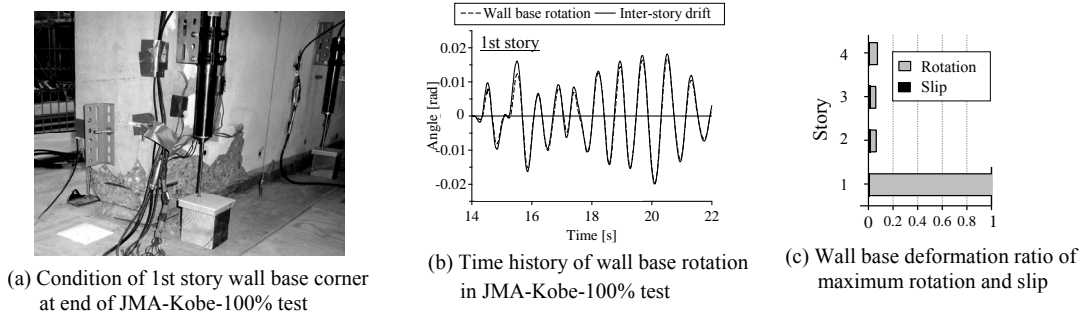
Figure 13. Local damage and deformation of PT wall base at C-axis for JMA-Kobe-100% test

Figure 13 (a) shows the condition of the first story wall base corner at the end of JMA-Kobe-100% test. The core concrete in that region is adequately confined by lateral reinforcement. That region separated from the foundation in tension due to the overturning moment. Rotation and slip deformations of the wall bases were measured in Y direction. The time history of wall base rotation is shown in Figures 13 (b) and compared with the first story drift at C-axis. The wall base rotation and the first story drift are almost equal in the JMA-Kobe-100% test. Figure 13 (c) shows the deformation ratios, which are defined as the ratios of the maximum wall base rotation and slip to the maximum inter-story drift, for the first to fourth story. The deformation ratios of rotation are much smaller in upper stories than that in the first story, indicating that the majority of wall deformations is due to the rotation at the first story wall base. The deformation ratio of slip is close to zero in the first to fourth story.

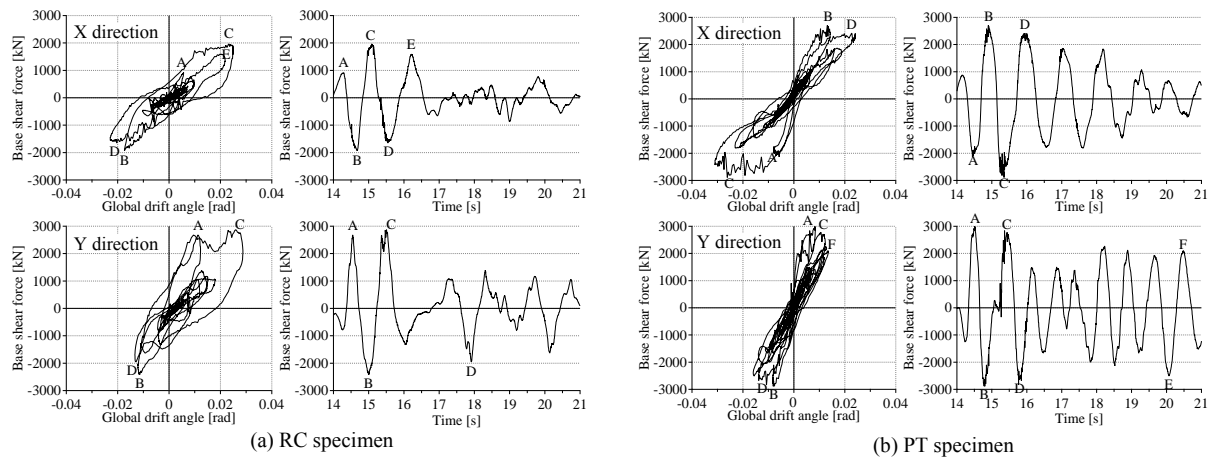
Figure. 14 Base shear force-global drift relationship and base shear force time history in JMA-Kobe-100% test

RC and PT specimens sustained significant deformations in the JMA-Kobe-100% test. Figure 14 shows the relationship between base shear force and global drift angle for the JMA-Kobe-100% test, with the time history of base shear force. The base shear force was estimated from the horizontal inertia force. The horizontal inertia force was obtained as the measured acceleration times the floor mass. Global drift angle was defined as the fourth floor drift divided by its elevation. The base shear force and global drift angle were estimated at the center of floor. In the relationships between base shear force and global drift angle of the both specimens, the slope of the loading branch significantly decreased after the global drift angle exceeded 0.01 rad. The maximum base shear forces are close in the Y direction of RC specimen and the X and Y directions of PT specimen. The unloading branches of PT specimen show a trend of drift recovery. The time histories of base shear force show the elongation of the first mode period due to degrading of the slope. The natural period of RC specimen estimated by the White-noise input after the JMA-Kobe-100% test was 0.99 sec in X direction and 0.88 sec in Y direction, and that of PT specimen was 0.69 sec in X direction and 0.52 sec in Y direction.

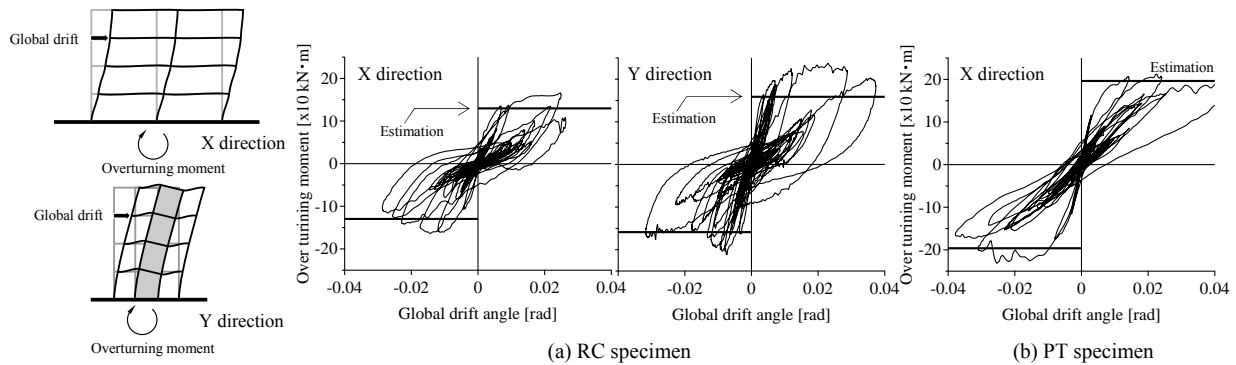
Figure. 15 Estimation of strength capacity based on Japanese Building Standard

For the X and Y directions of RC specimen and the X direction of PT specimen, seismic designs were applied according to the present Japanese seismic design code. Their capacity strengths were checked by using pushover analysis in reference to provisions of the document published by the Ministry of Land, infrastructure, Transport, and Tourism (2007, 2009). The flexural strengths of the beam, column and wall were evaluated reflecting the compressive strength of concrete and the yield strength of steel reinforcement given by the material test. Reinforcement of the top slab was reflected in the flexural strength of a beam section in negative bending (top in tension). Since the overturning moment at the base of the first story is mostly produced by the first mode response of a structure and is relatively insensitive in pushover analysis to the distribution of the lateral loads, experimental and pushover strength capacities can best be compared through the overturning moment. Figure 15 shows the relationship between overturning moment and global drift angle given from the JMA-Kobe-25% to JR-Takatori-60% tests, and the strength capacity estimated by the pushover analyses at the maximum inter-story drift angle of 0.02 rad is compared to it. In X direction, the strength ratio of the maximum test strength to the estimation is 1.3 for RC specimen and 1.1 for PT specimen, although the maximum test strength of PT specimen is 1.4 times that of RC specimen. In Y direction, the strength ratio for RC specimen is 1.5. This indicates that the presence of multi-story wall increases the actual difference.

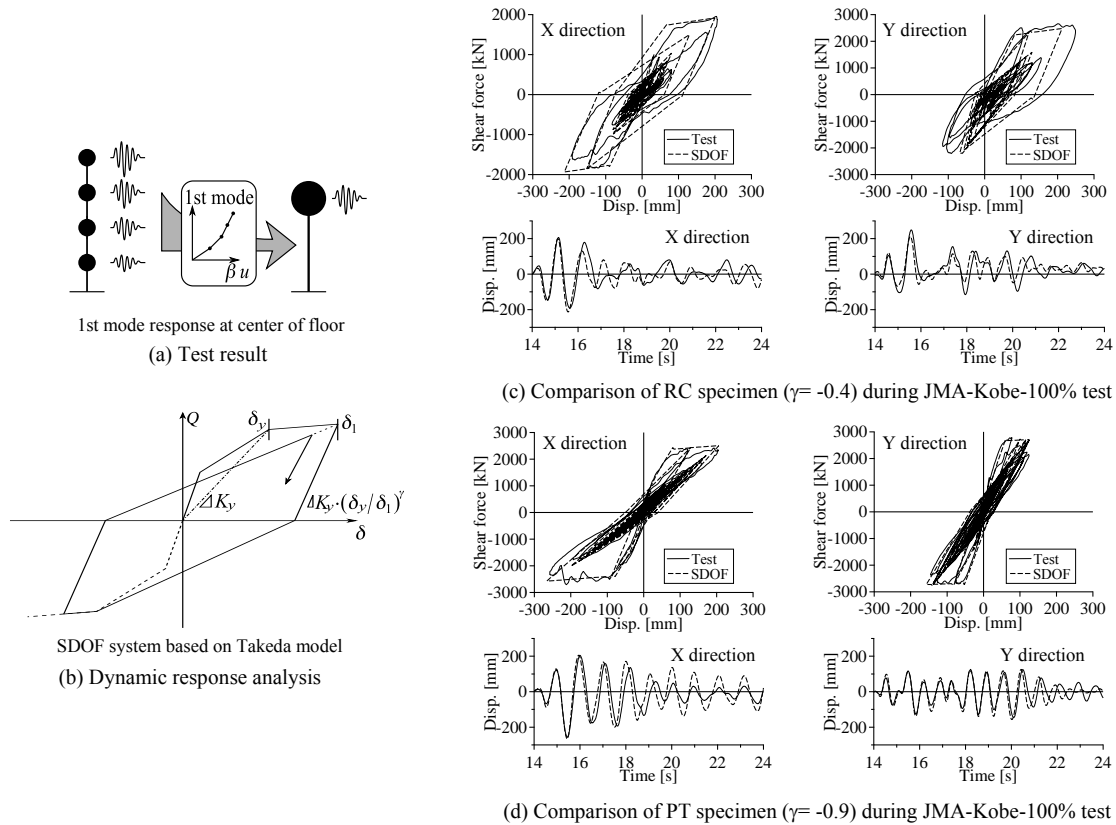
Figure 16 SDOF dynamic response analysis using fitted skeleton curve and tuned Takeda model

Figure 16 shows the first mode responses of RC and PT specimens comparing to outputs of SDOF dynamic response analyses. The adopted SDOF system has a fitted skeleton curve and a tuned hysteretic rule defined by Takeda model. In the analysis, the test motions recorded in each directions were sequentially input from JMA-Kobe 25 % to JMA-Kobe 100 % with a long interval, and the initial damping ratio of 5 % was changed in proportion to the instantaneous stiffness. For both RC and PT specimens, the analyses well reproduced the large displacement responses in each directions. The factor to define unloading slope γ became -0.9 for PT specimen corresponding to the recovery shape, while that for RC specimen was -0.4. Those comparisons are simple, but the reasonable correlation essentially indicates that the dynamic response analysis given a proper model provides a reasonable performance assessment for the RC and PT building structures.
